Emergency Stabilization: West Seattle High-Rise Bridge

Washington ACI Chapter & SEAW Joint Meeting

February 16, 2022

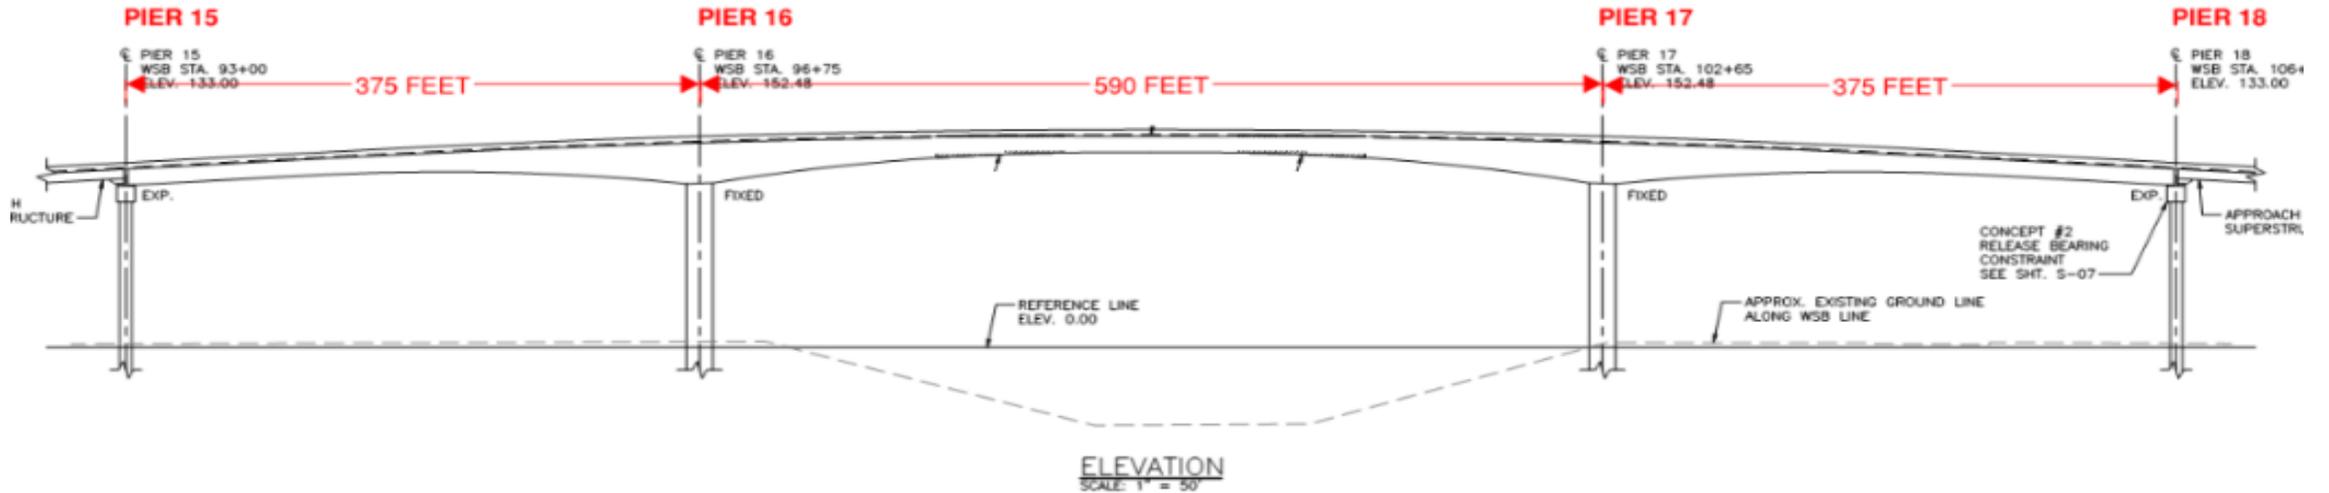
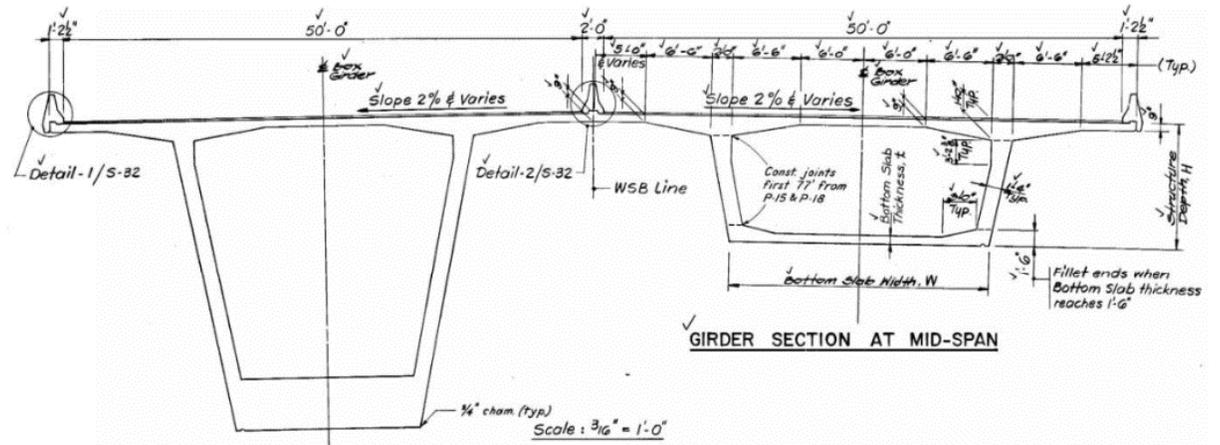
Bridge Details

- Elevation (top)
 - Main span 590'
 - Flanking spans 375'
- Section (bottom)
 - Near Pier Table (left) $h \sim 30'$
 - Near mid-span (right) $h \sim 12'$

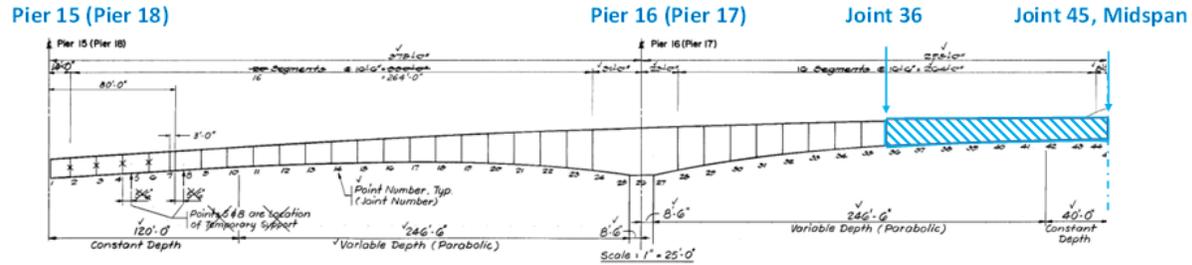
Figure 9: Longitudinal elevation. Pier 15 to the mid-span (the west half).

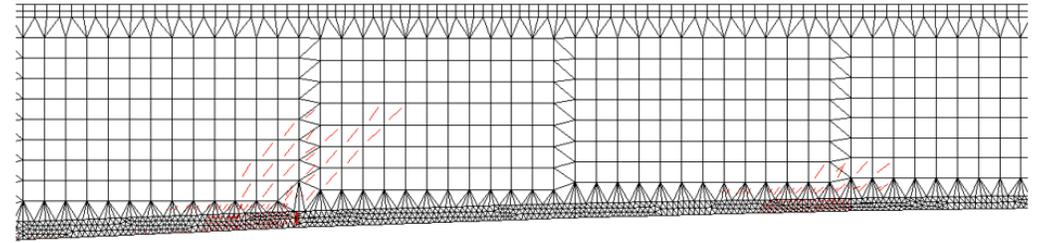
Figure 22: Crack diagram at load factor 0.9 of Phase I.

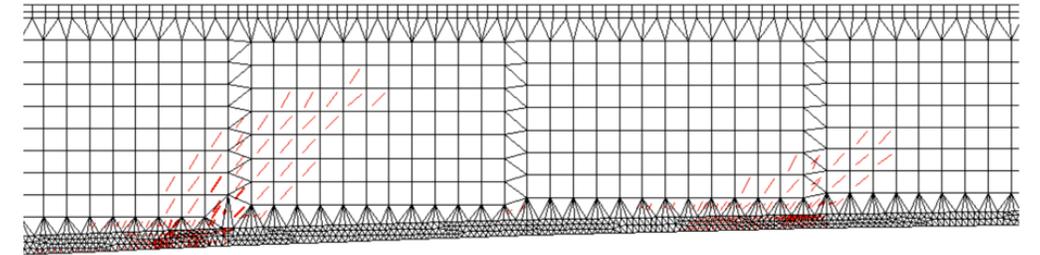
Figure 23: Crack diagram at load factor of 1.0 from a previous analysis

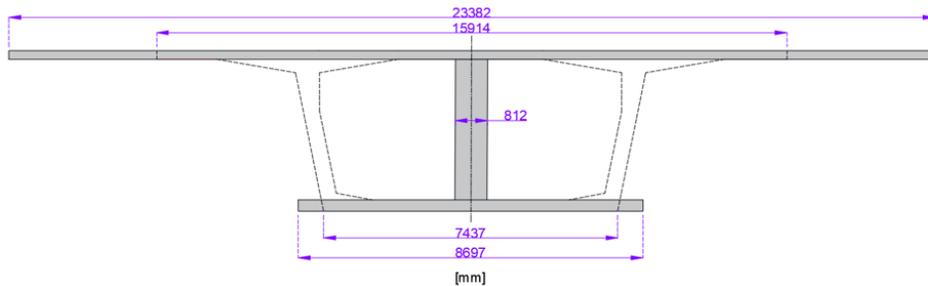
Figure 13: The analyzed I-shape beam cross-section (red) and the original cross-section (dashed line) at segment 12.

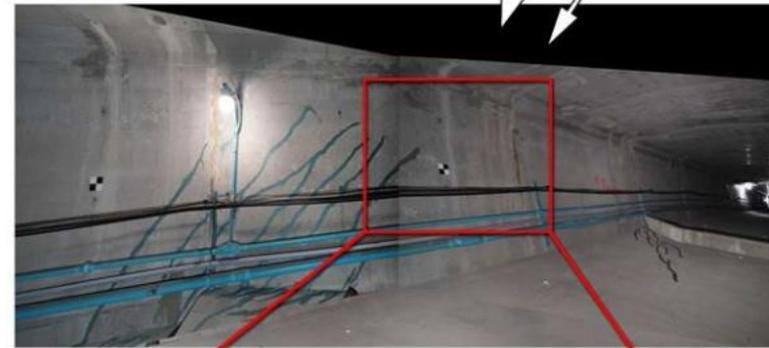
Interior of West Seattle Bridge showing outer wall and underside of road deck.

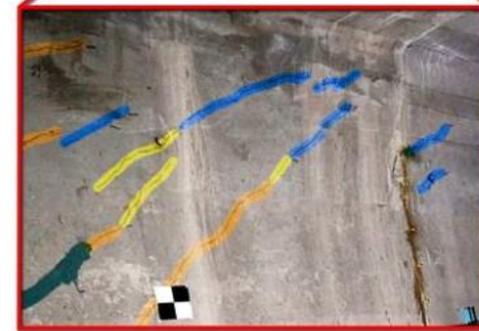
Previously identified cracks 2013 - August 2019
Observed Growth December 2019
December 2019 - March 6 2020
March 6 2020 - March 23 2020

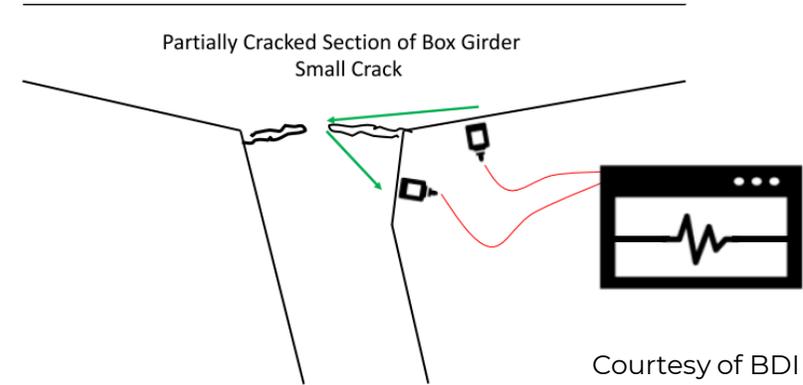
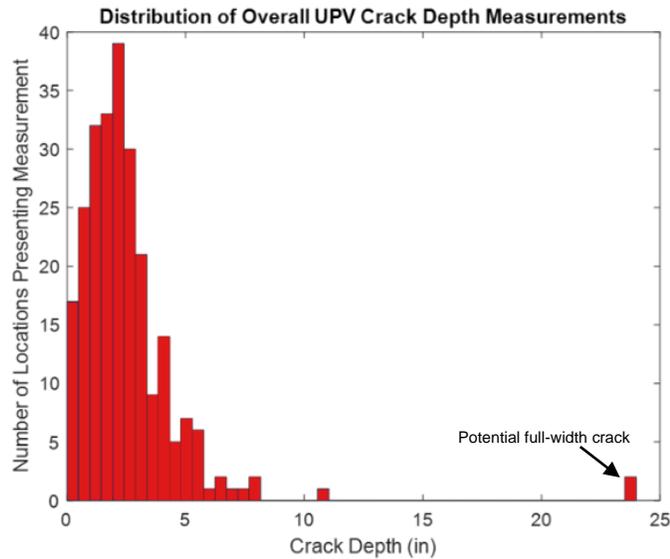
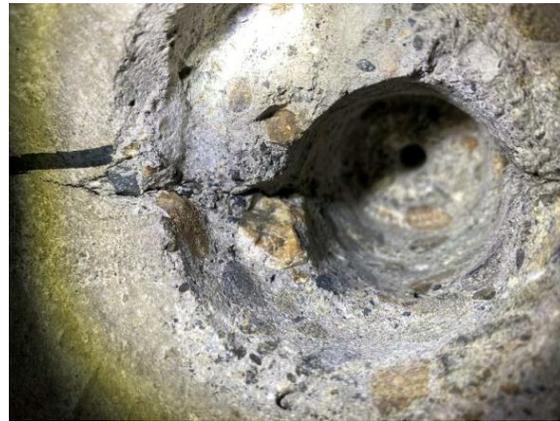
Ultrasonic Pulse Velocity (UPV)

- UT probes above and below web-deck chamfer

- Full-depth cracks (no signal)
- Depth of crack (time-of-flight)

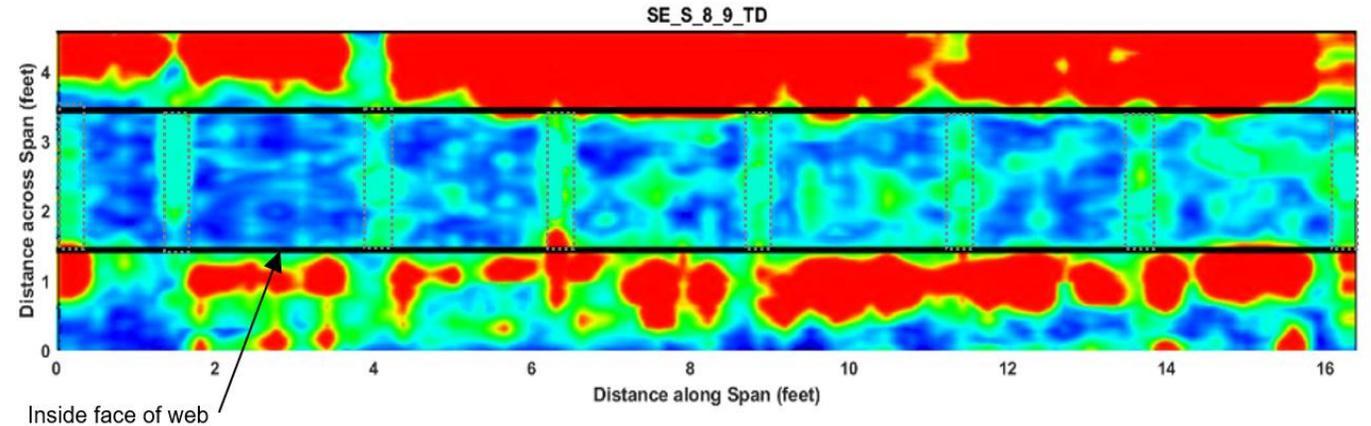
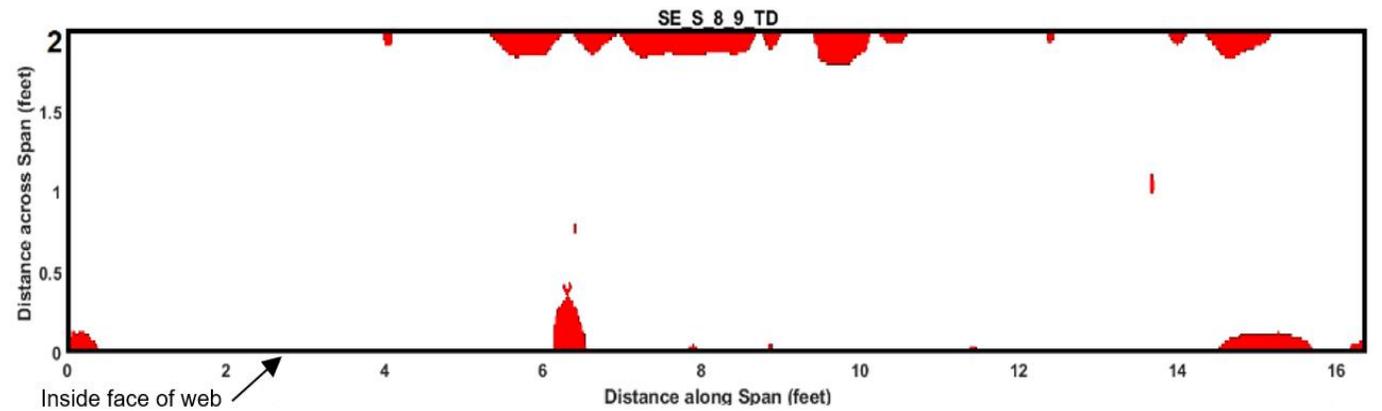
Ultrasonic Tomography Results as a Section Taken at Top of Web.

- Scans from top of deck above web
- Assess depth of crack plane
- Compare to UPV results

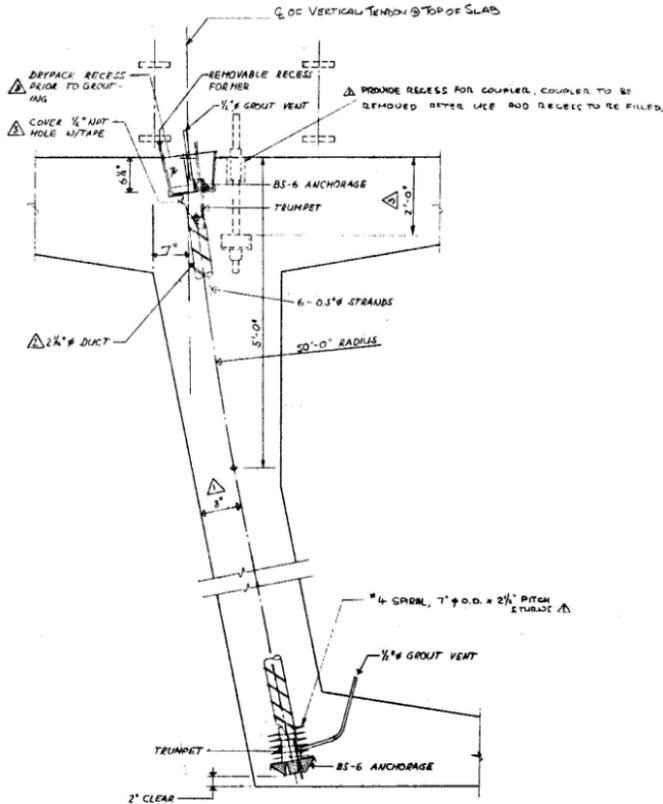
VERTICAL WEB TENDON ARRANGEMENT

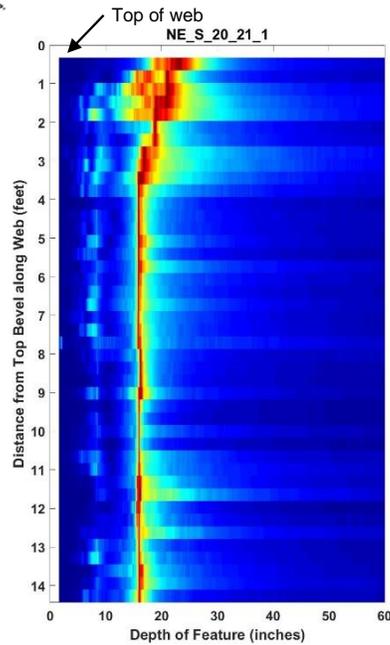
Intact grout

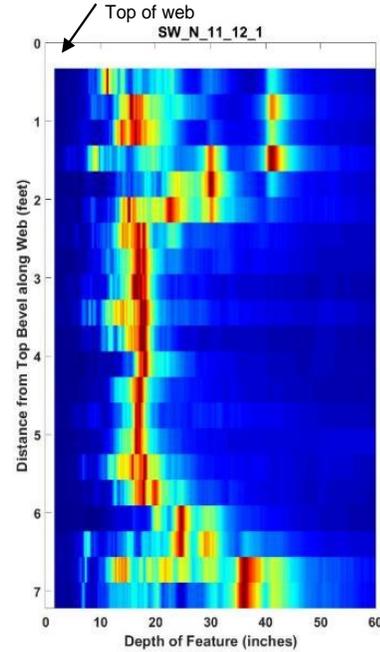
Voids in grout

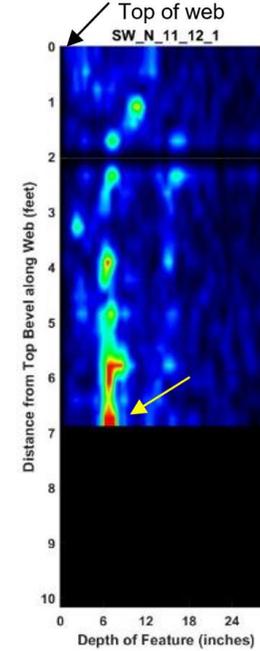
Voids in grout

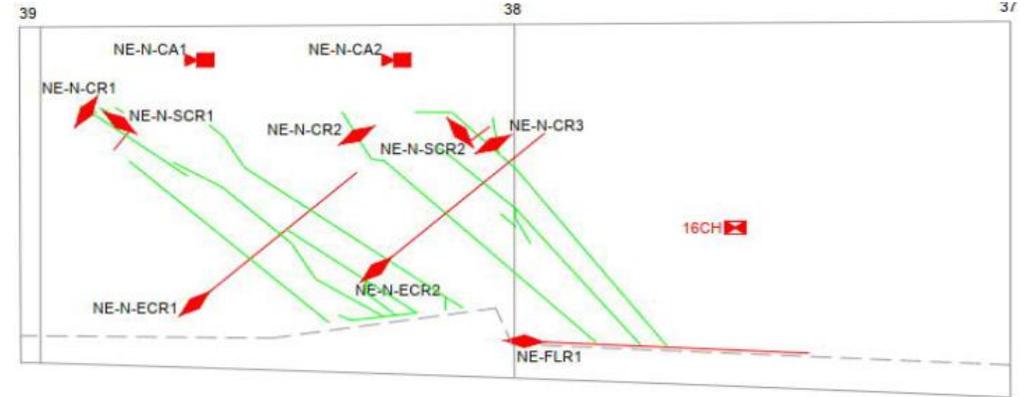
- Main span deflection– MEMS Shape Array
- Crack growth – vibrating wire crack gages
- End-span displacements – string potentiometers
- High resolution cameras
- Monitoring website with Alarms

West Seattle High-Rise Bridge Intelligent Monitoring System

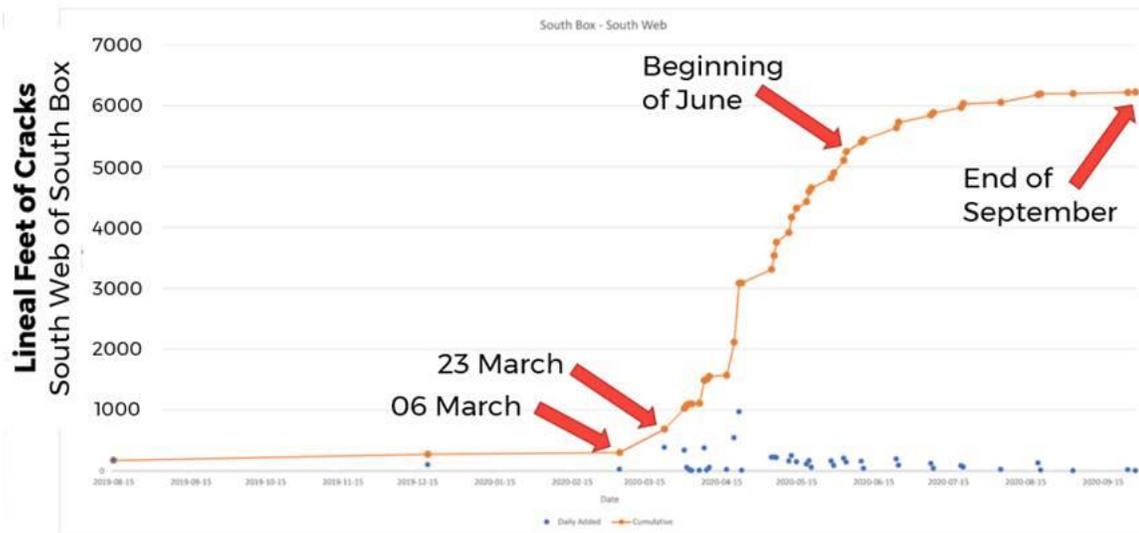
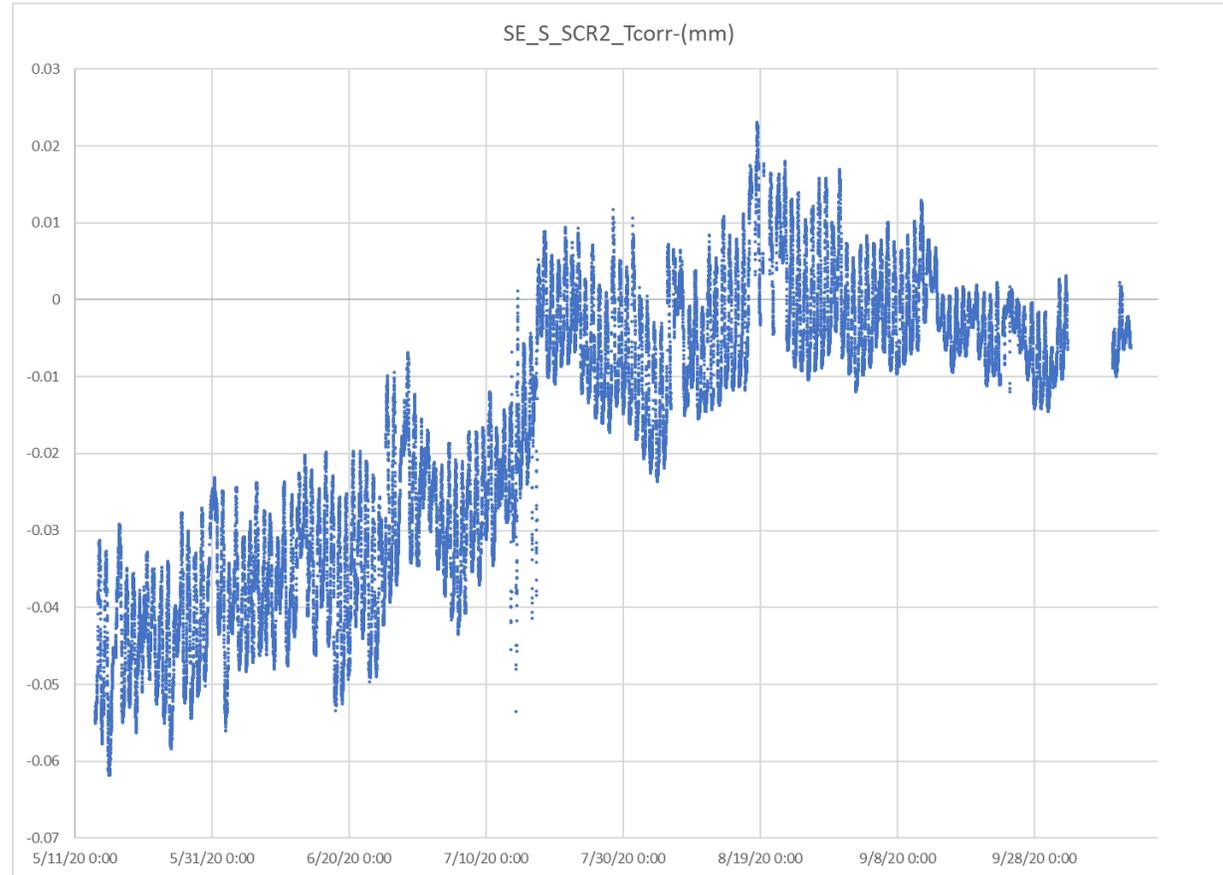
Crack growth has slowed since the spring

- Manual Measurements of crack length
- Temperature-corrected measure of crack slip

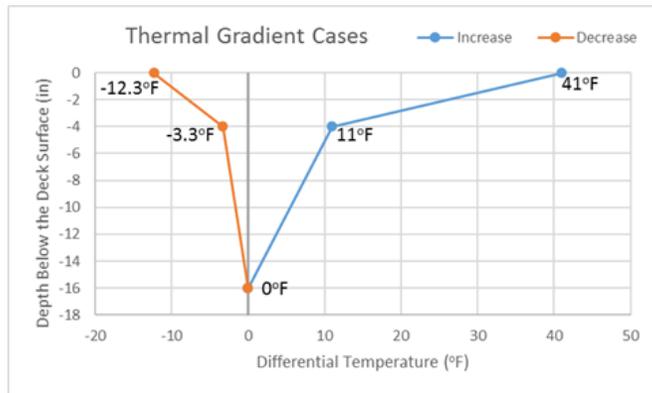
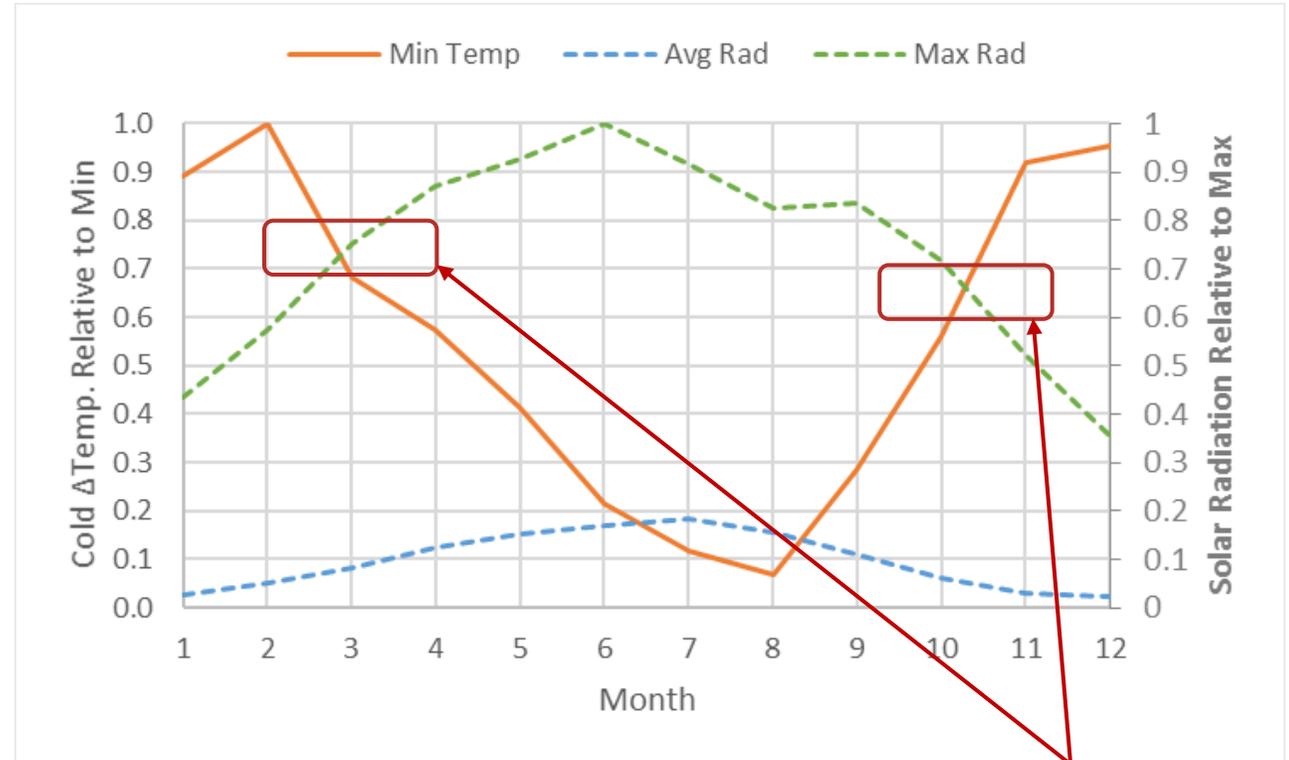
(Deg F)	(W/m ²)	Temperature (Deg F)
	Temperature	Solar Radiation	Relative to Avg
Avg	53.3	129.5	0
Min	16.9	0	-36.4
Max	103	1355	49.7

- Predictions made using University of Washington weather station temperature and solar radiation data as input.
- <http://www.weatherjon.org/meteo/pages/station/table.php>

Worst combination TU + TG is Spring and Fall seasons

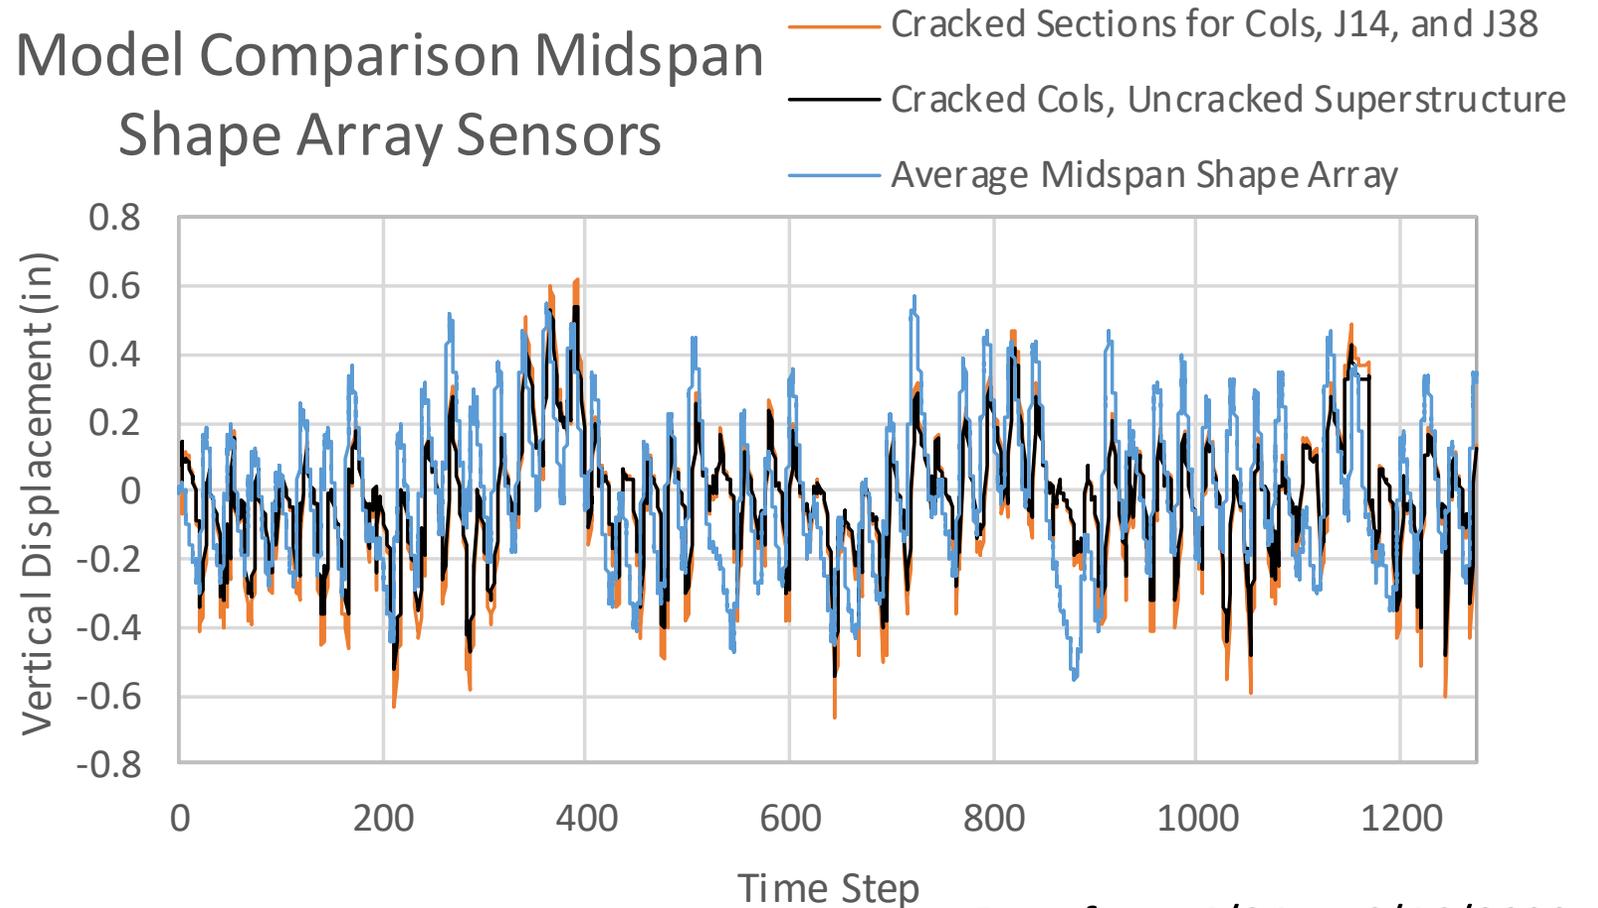
- Same process used to scale TU and TG midspan vertical displacements using weather station temperature and solar radiation data.

Model Comparison Midspan Shape Array Sensors

Data from 4/24 to 6/16/2020
